General Repair Information

GRI-07-C-006
24th September 2007
General Repair Information/
C100

C100 P2138, P2120 & C0561 Wiring Harness Repair Procedure

MODELS: C100 All engine variants

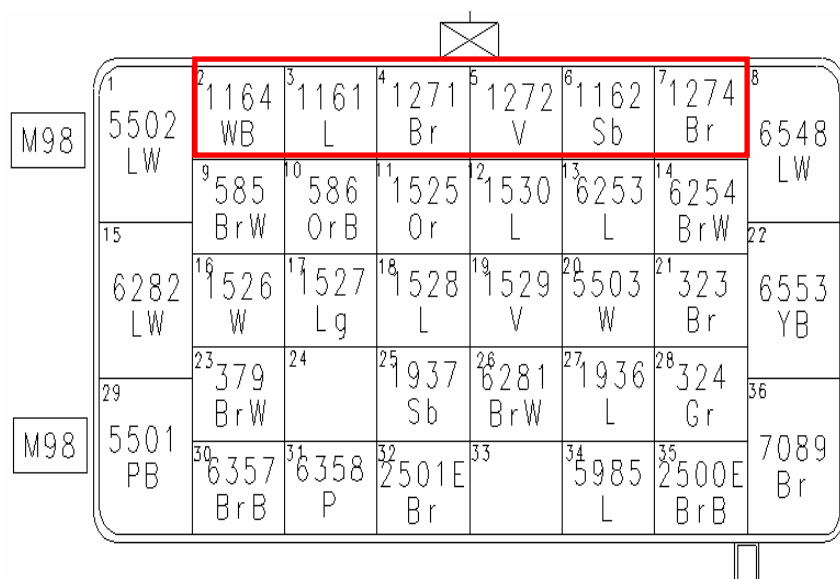
TYCO 1743636-2(W/COVER: TYCO 1743638-2)
TO BODY WRG

Following the checking procedures the technician may diagnose that the ECM or throttle pedal sensor is defective, but it is actually an intermittent wiring fault in the connector X101.
